- USAFOEHL REPORT

**CONTAMINATION OF THE EXTERIOR OF A
C-130E AIRCRAFT USED FOR AERIAL SPRAY,
907 TAG, RICKENBACKER ANGB OH**

September 1988

Final Report

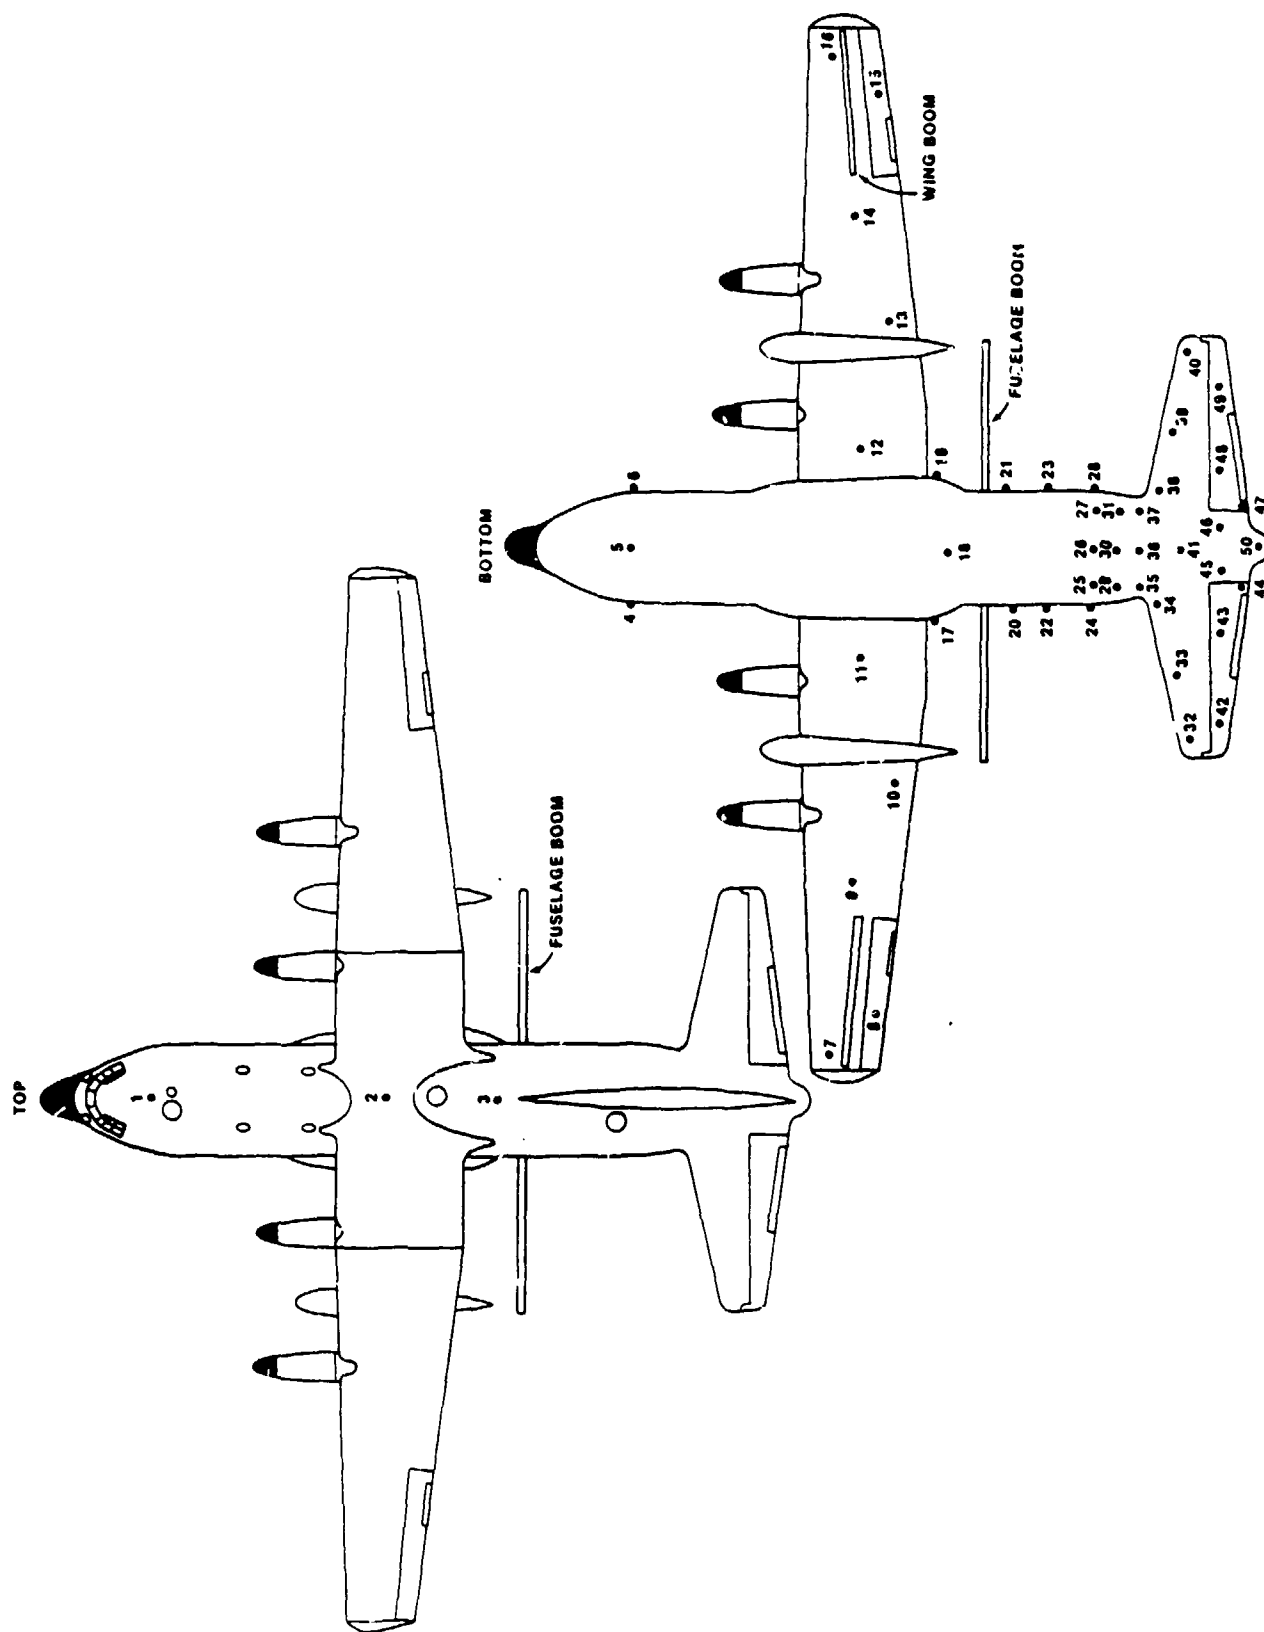
Figure 1. Location of monitoring cards on exterior of C-130E aircraft during evaluation of Modular Aerial Spray System.

All paper index cards were negative after the preliminary flight test. However, background contamination occurred at locations 10, 11, 12, and 13 (Fig 1) when oil sensitive cards were used. The oil came from the aircraft engines, but it did not interfere with the evaluation because the drops were large and thus distinguishable from spray droplets. Also, negative results at the same locations during definitive tests when paper index cards were used to detect red dye, applied through the wing booms, indicates that material from the spray system did not contaminate the underside of the wings near the engines.

Light contamination of the aileron (cards 8 and 15, Fig 1) occurred when wing booms were used to apply soybean oil and water. The same locations were negative when Dibrom and Malathion were applied at lower rates with smaller droplets, however, one card (3, Fig 1) on top of the aircraft near the tail received light contamination during the third flight involving Malathion (Table 1). The aircraft most likely flew through a cloud of spray which was kept suspended by a temperature inversion. All other cards were negative on the horizontal stabilizer (Fig 2B), cargo door, wings, and fuselage when the wings booms were used. An additional piece of oil sensitive card taped to the back of a nozzle was positive after Dibrom application. The chemical moved up a low pressure area on the back of the nozzle, but did not contaminate the wing above the spray boom. This does not pose a problem because nozzles must be replaced for various other reasons after prolonged use.

B. Only one oil sensitive card was positive on the C-130 after applications of Dibrom and Malathion. The card (3, Fig 1) was on top of the aircraft where the tail joins the fuselage. This occurred when Malathion was applied during a temperature inversion; the plane most likely flew through the spray after application.

A. The spray booms and area of the wings above and behind the booms (particularly the aileron) should be washed with soap, water, and a scrub brush within 24 hours after each flight involving application of corrosive material.

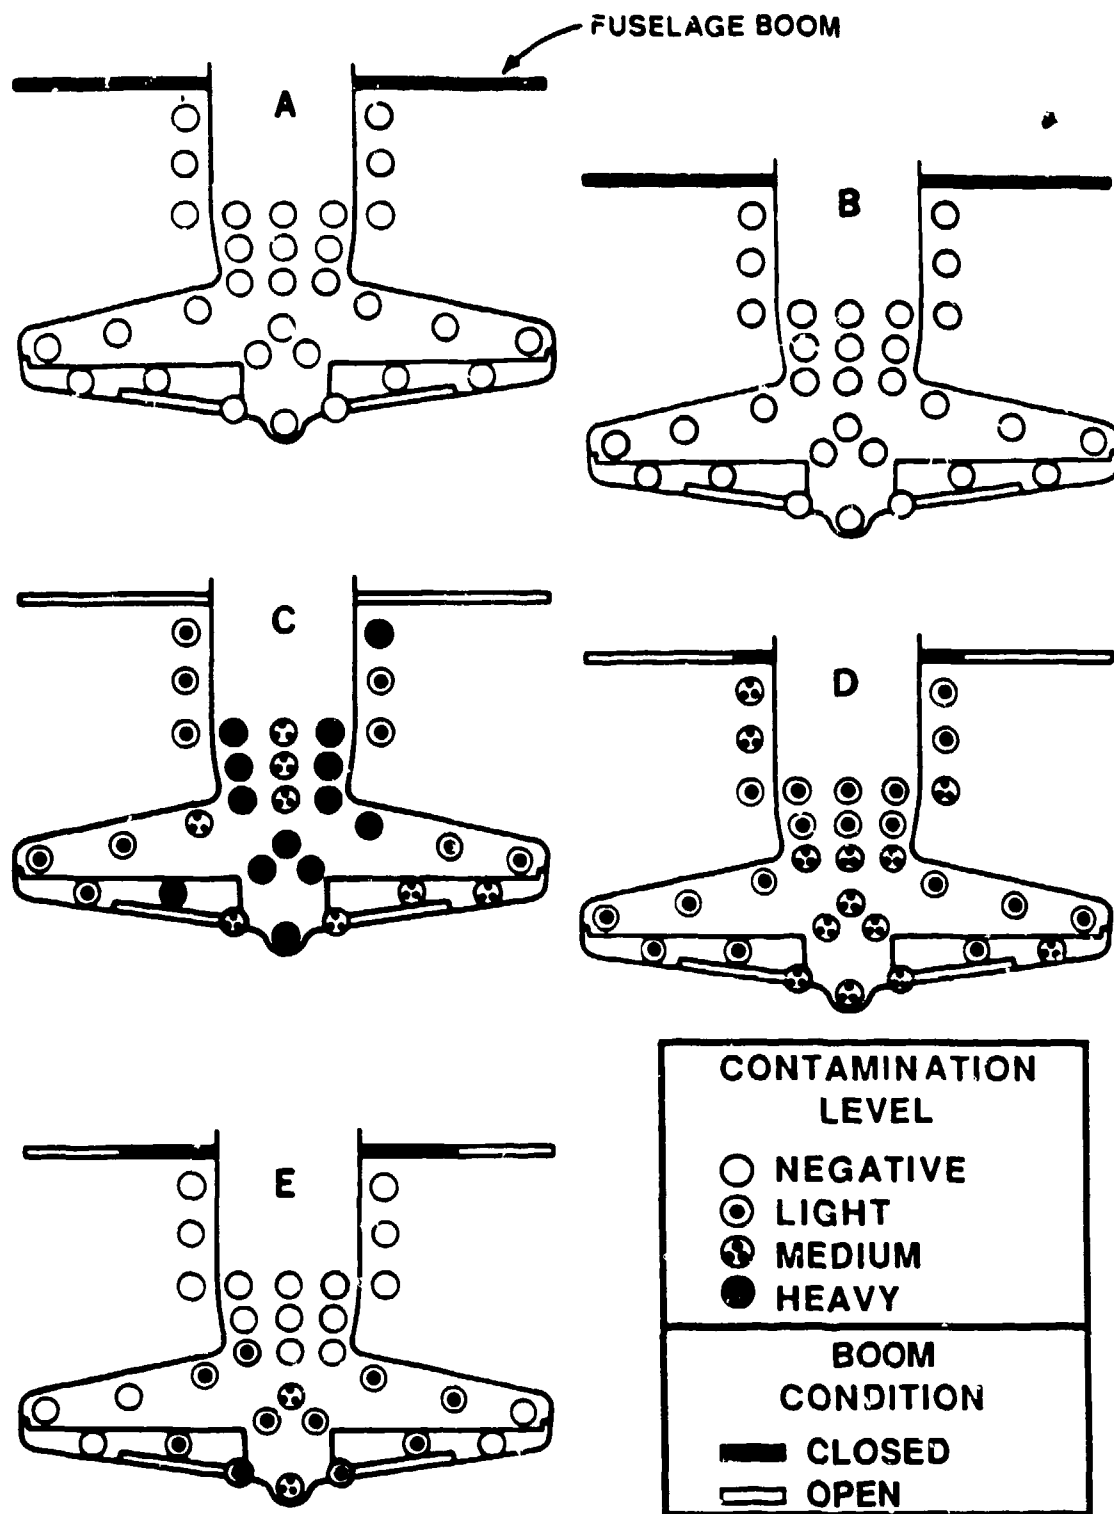
The cargo door and horizontal stabilizer (Fig 2C) were heavily contaminated with red dye when the fuselage booms were used. Deposition of material during flight was not apparent when viewed from the ground or video films taken by a chase plane, but cards near the outer edges of the cargo door and rear fuselage were saturated with red dye. Contamination was so heavy that red dye could easily be seen on the aircraft. Some of the dye flowed up the rear of the fuselage and onto the top of the horizontal stabilizer. Spray nozzles closest to the fuselage were the most likely source of the material because the amount of contamination decreased after 10 nozzles were closed on each boom (Fig 2D) and a further decrease in contamination was observed when 24 nozzles were closed on each boom (Fig 2E).

Figure 2. Contamination of the rear of a C-130E aircraft after: A. Spray system not used; B. Wing booms used; C. Fuselage booms used with 114 nozzles opened; D. Fuselage booms used with 94 nozzles opened; E. Fuselage booms used with 66 nozzles opened (view of underside of aircraft).

E. The underside of the horizontal stabilizer and cargo door, and the side of the fuselage were heavily contaminated with red dye when all nozzles were opened on the fuselage booms (Fig 2). The amount of red dye deposited on each card decreased when nozzles closest to the fuselage were closed; however, spray deposition may have been affected. A compromise must be made if fuselage booms are used. Aircraft contamination can be reduced by closing nozzles, but additional flying may be needed to obtain complete coverage with spray material.

B. The fuselage booms should not be used to apply corrosive materials because the underside of the cargo door and horizontal stabilizer will be contaminated.

C. The underside of the cargo door and horizontal stabilizer should be washed with soap, water, and a scrub brush after any type of pesticide is applied through the fuselage booms.

D. Contamination of the underside of the cargo door and horizontal stabilizer can be significantly reduced by closing nozzles closest to the fuselage whenever the fuselage booms are used.
